PFPNet Houston 2025

Assessment and Repair of Damaged PFP

Simon Thurlbeck, PhD CEng
Director, PFPNet

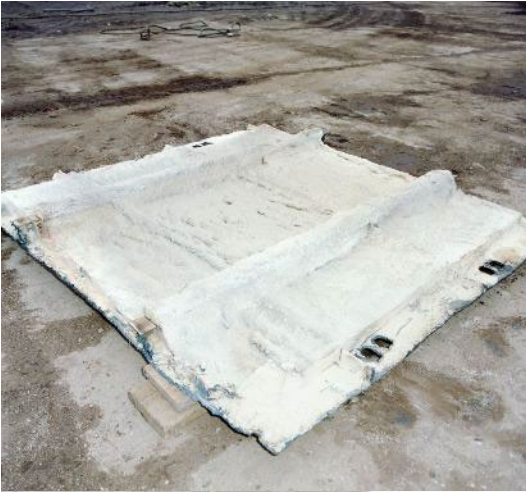
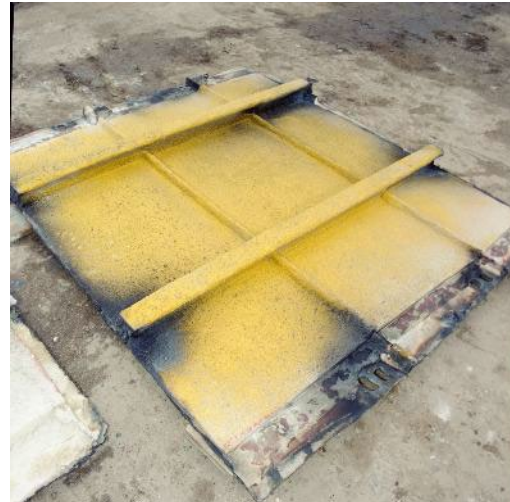
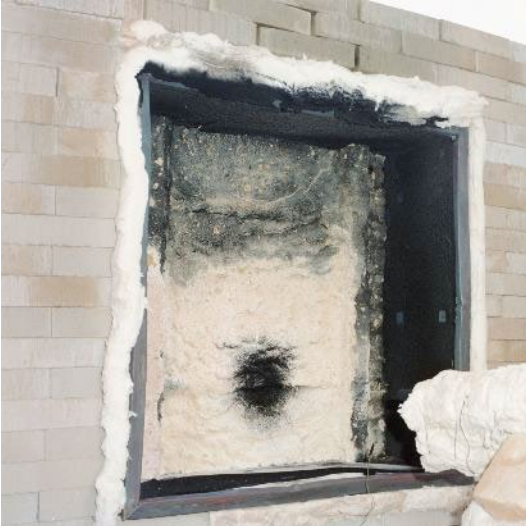
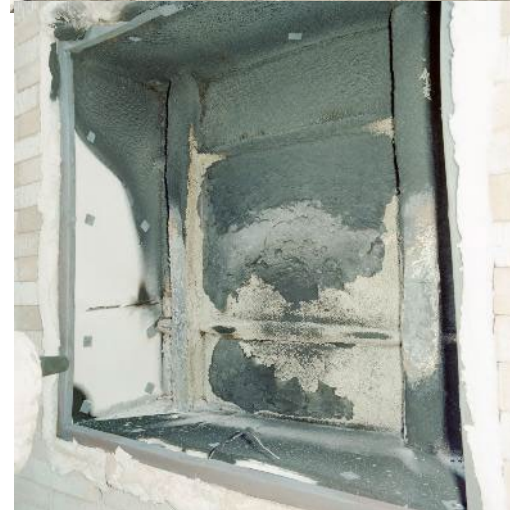
30 Years in the North Sea

- Mandolite M40 and Chartek 59
 - Originally for A60 bulkheads
 - Subject to hydrocarbon pool and jet fire testing for 2 hours
 - Looking for time to 140°C on panels and 400°C on webs
-
- Both materials good on panels
 - Both underperformed on webs but gave some performance
 - Cause: thinner material and mesh location

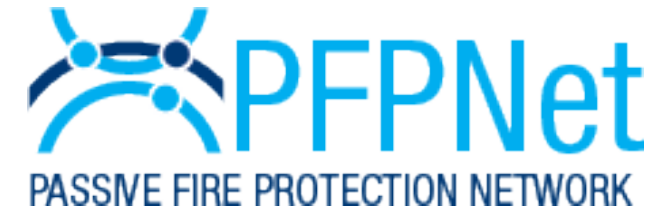
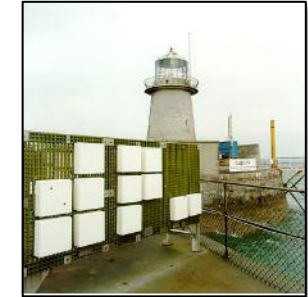
Shell/HSE Long Term Weathering Tests

PFP	Weathering	Thickness (mm)	Reinforcement
Chartek III	10.7 years	22	Wire mesh at 5 mm
Chartek IV	8.5 years	15	Wire mesh round perimeter Carbon / glass mesh at 8 mm
Firetex M90	7.5 years	19	H120 scrim mesh at 9 mm
Mandolite 550	12.4 years	45	Wire mesh at 30 mm
Pitt-Char XP	10.7 years	29	No mesh – only 5 x 30 mm diameter washers at 14 mm
System E (Mandolite 990)	8.5 years	19	Wire mesh at 10 mm
Thermolag 400	10.7 years	20	Wire mesh at 10 mm

All coatings
Initiated in 1990 – 35 years ago
Coated to H120 specification
CUF occurred at edges due to poor preparation
PittChar XP suffered from this preparation issue

PFP	Thick-ness (mm)	Furnace test mean time for 140 °C rise (minutes)		Fire resistance after weathering ± 12 min.	Jet fire test mean time for 140 °C rise (minutes)	Fire resistance after weathering ± 15 min.
		Initial	Final			
Chartek III	22	72	67	SAME	97 top	BETTER
Chartek IV	15	54	56	SAME	77 top	SAME
Firetex M90	19	66	68	SAME	56 bottom	SAME
Mandolite 550	45	87	> 120	BETTER	117 bottom	BETTER
Pitt-Char XP	29	68	87	SAME	35 bottom	WORSE
System E	19	68	62	SAME	44 bottom	SAME
Thermolag 440	20	51	99	BETTER	113 bottom	BETTER

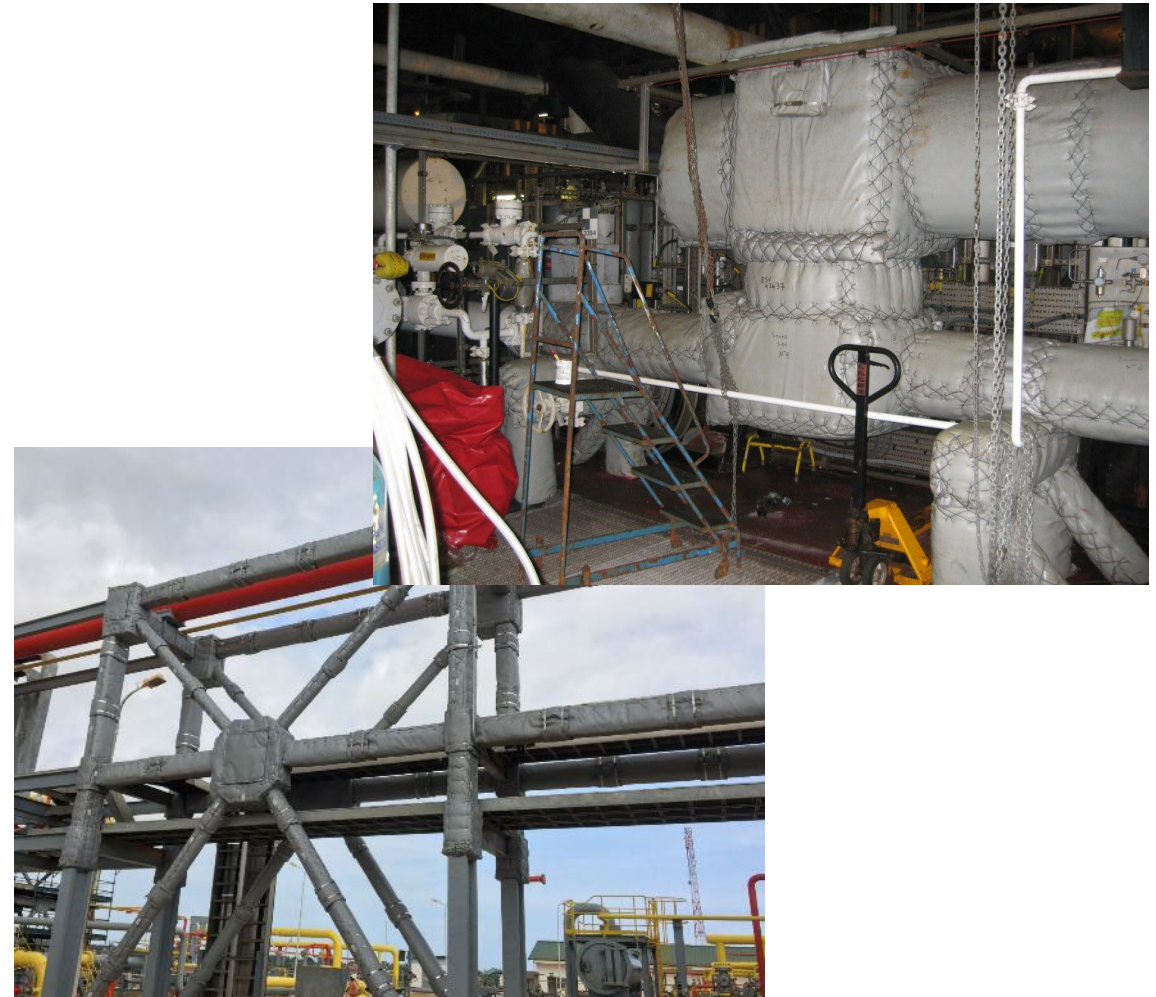
Jacket Systems

Damage	Description	Severity
Pack Thickness	Are any Panels reduced in Pack Thickness	1
Missing Items	Are any Panels Missing:	1
	Are any Joint Covers Missing:	1
	Are any Rain Covers Missing:	3
Joints	Are insulated joint covers fitted:	1
	Are Corner Joints a Good Fit-up:	1
	Overlap Joints to Correct Dimension:	1
	Are butt joints fully tightened:	2
	Are corner joints fully tightened:	2
	Are overlapping joints fully tightened:	2

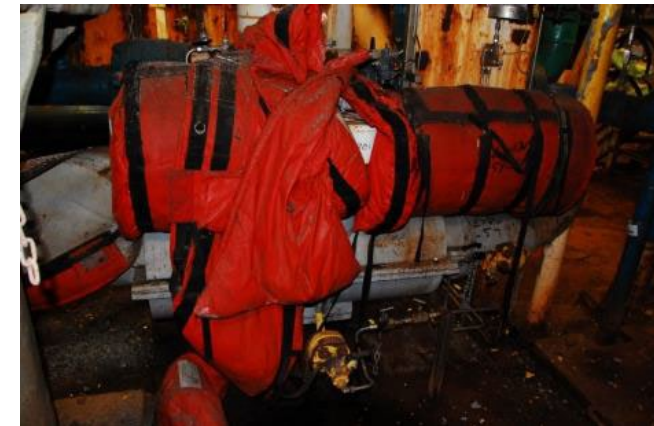
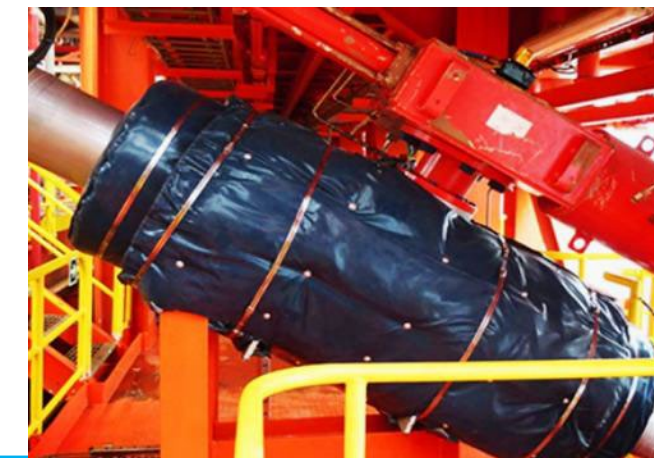
PFP Jacket System – Damage Assessment Checklist

Damage	Description	Severity
Mechanical Fastening	Is there Mechanical Fastening:	1
	Is system retained by installation aids only:	1
	Is Banding Fitted at Terminations:	1
	Are some belts & buckles missing:	2
	Are some lacing anchors missing:	2
	Are some lacing loops missing:	2
	Are belts & buckles loose / unfastened:	2
	Is some Single Lacing Wire Missing:	2
	Single Lacing in Place Rather Than Double:	3
*If a Fastener is Loose, Tighten Immediately.		3

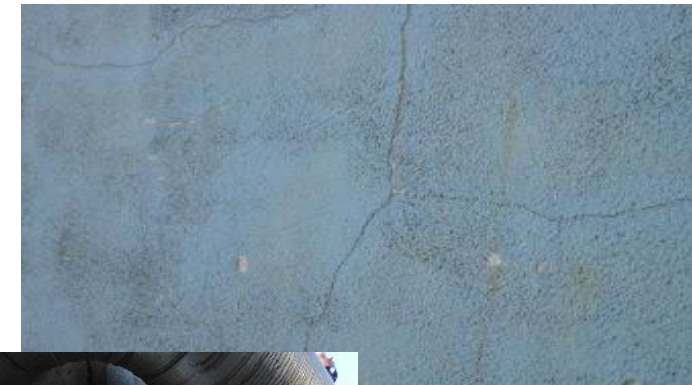
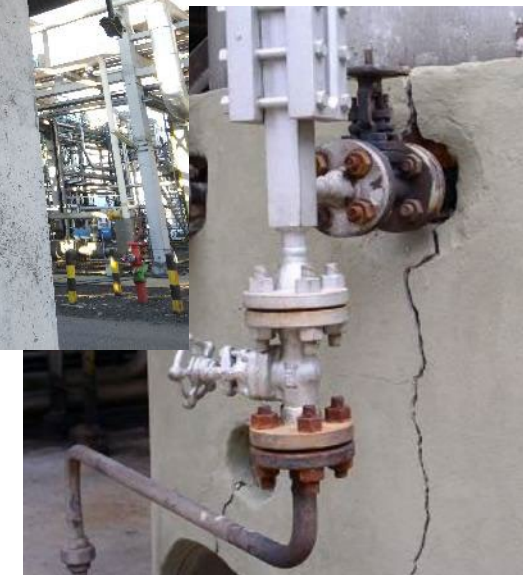
Damage	Protected Item	Description	Severity
Individual area of mechanical damage (gouge, scrape, chip, removal, etc) 3,000mm ² = 50 x 60mm = 2" x 2.5" 10,000mm ² = 100x100mm = 4" x 4"	Process Vessels and Barriers	Any area with remaining depth < 50% of thickness	1
		Area > 10,000mm ² with remaining depth > 50% of thickness	1
		Area between 3,000mm ² and 10,000mm ² with remaining depth > 50% of thickness	2
		Area <3,000mm ² with remaining depth > 50% of thickness	3
	Structural Steel And General	Any area with remaining depth <50% of thickness and located on an edge feature	1
		Area > 10,000mm ² with remaining depth < 50% of thickness – any location	1
		Area between 3,000mm ² and 10,000mm ² with remaining depth > 50% of thickness – any location	2
		Area <3,000mm ² - any depth – any location	3
Multiple areas of mechanical damage 500mm = 20"	Any	Two or more individual Severity Level 1 anomalies within 500mm of each other	1

Two or more individual Severity Level 2 anomalies within 500mm of each other	1
		Two or more individual Severity Level 3 anomalies within 500mm of each other	2

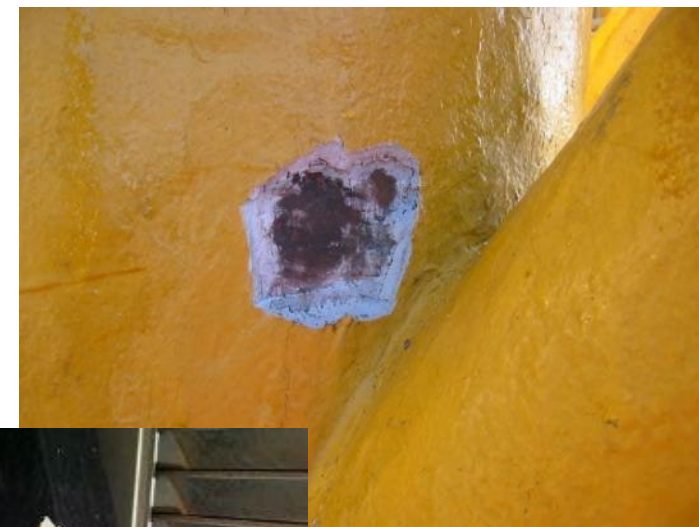
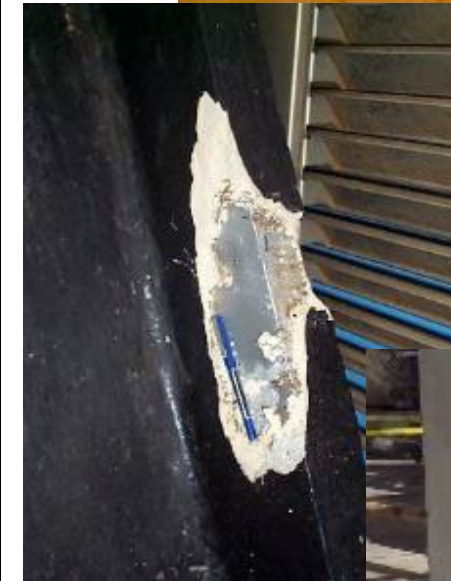
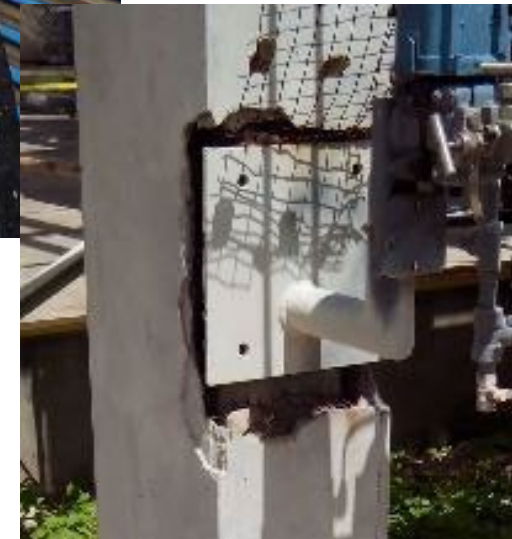
Damage	Protected Item	Description	Severity
General Material Loss	Any	Any area eroded down to/through retention system	1
		Surface spalling over a wide area of item	2
		Localised light surface spalling or surface erosion	3
Waterlogged Material	Any	Soft and corrosion product visible	1
		Soft and algae visible	2
		Soft on immediate surface only	3
Topcoat	Any	Large area over entire item is damaged	1
		Medium area or multiple small areas	2
		Small local areas	3
Terminations and Details	Any	Mastic seal missing or brittle	1
		Open/ disbonded termination	1
		Corrosion product at termination	1
		Material split and open at corner beads	1
Signs of Substrate Integrity Damage	Any	Wide open crack in LWC material	1
		Bulging, disbonded and cracked LWC material	1
		Leaching of corrosion products through LWC material	1

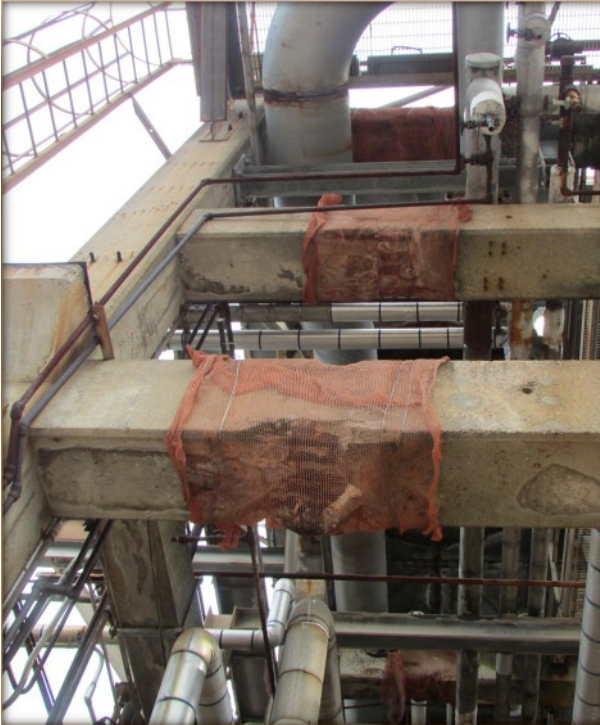
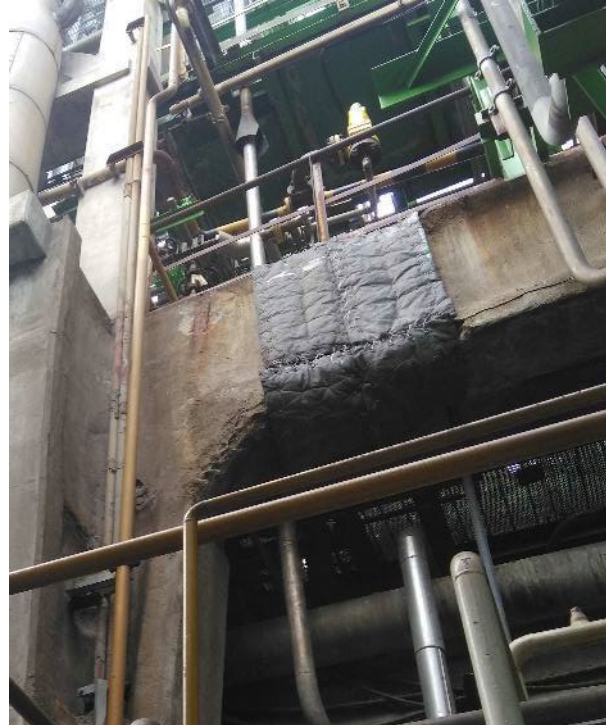
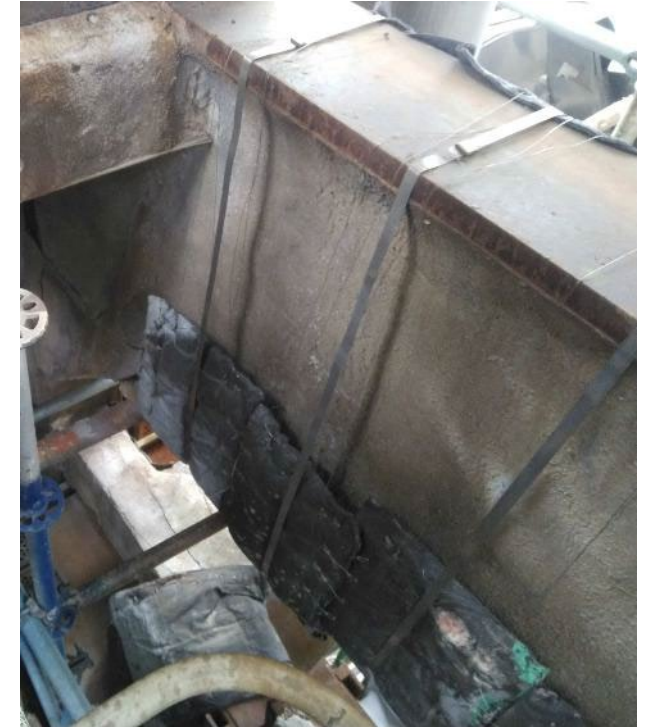
Temporary Repairs

No Certification, no testing
No fire resistance
Stopping material from falling

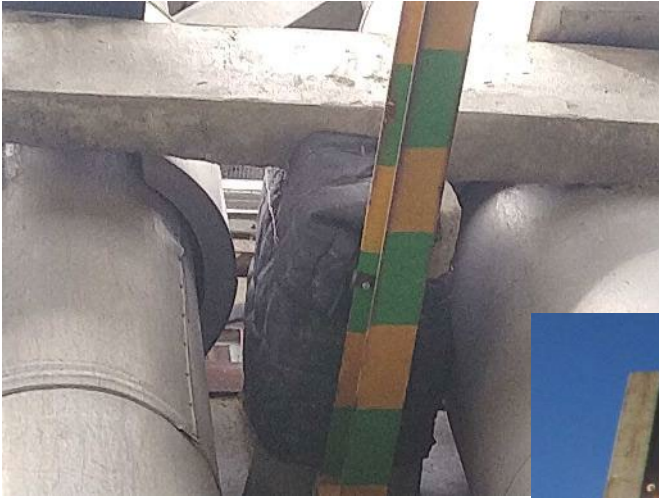
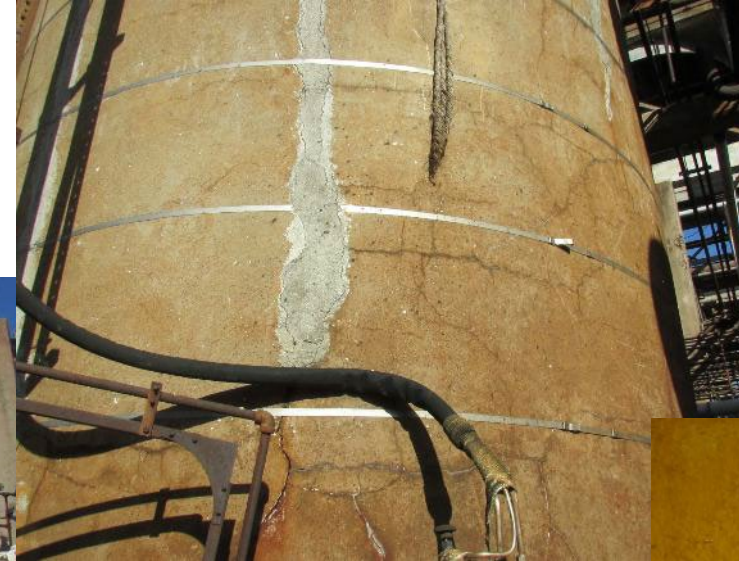
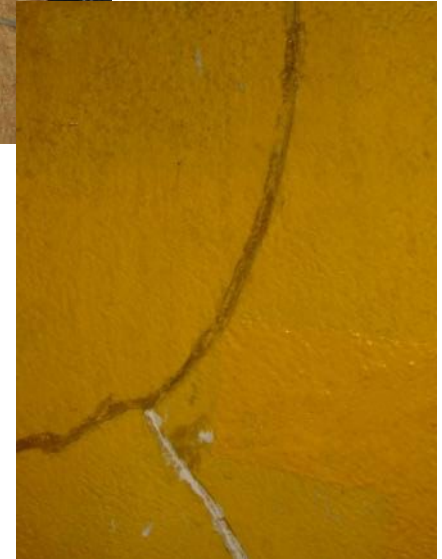
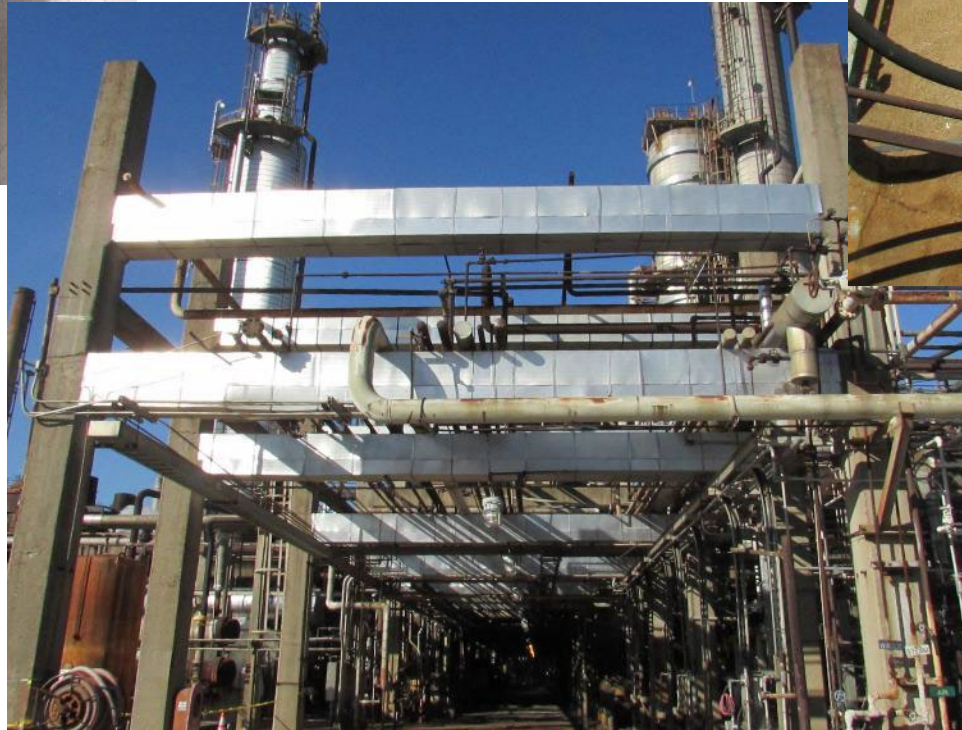
“Short/Medium” Term Repairs

Often ad hoc and
untested
Time limited
Evaluate impact on
risk

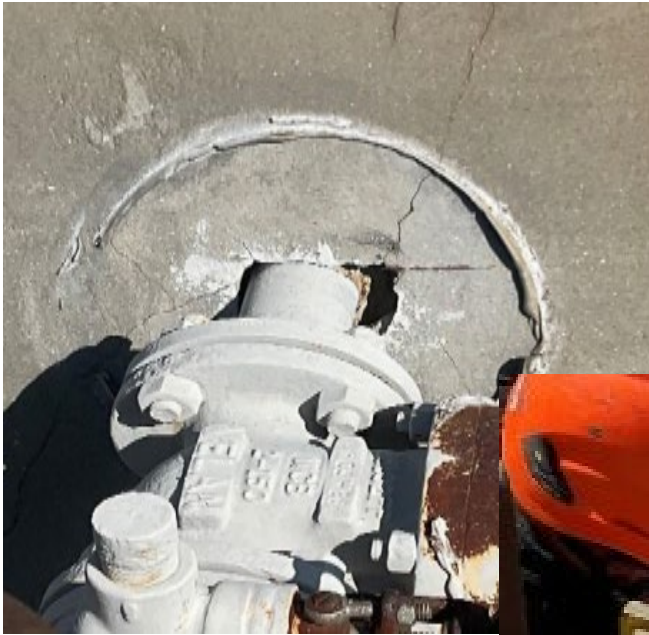
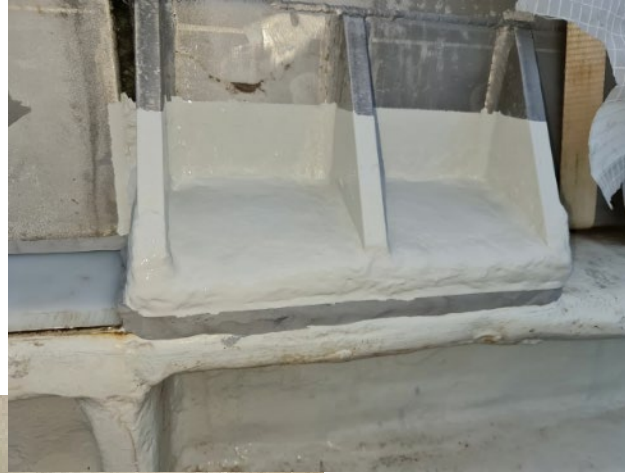
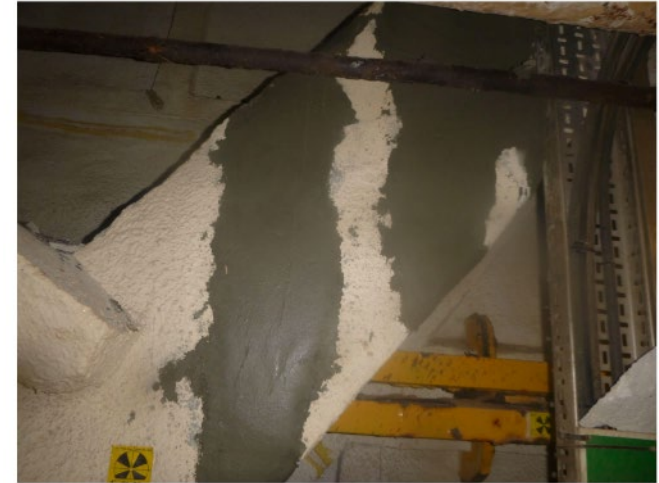
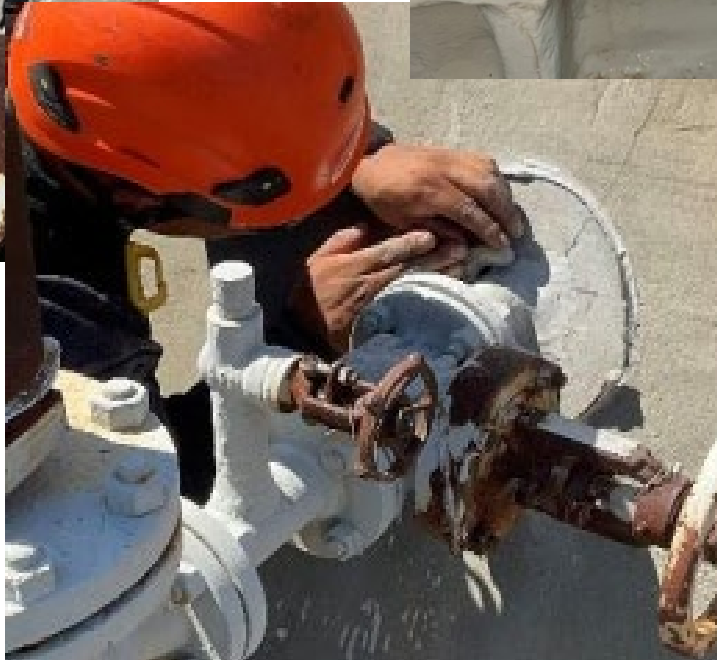
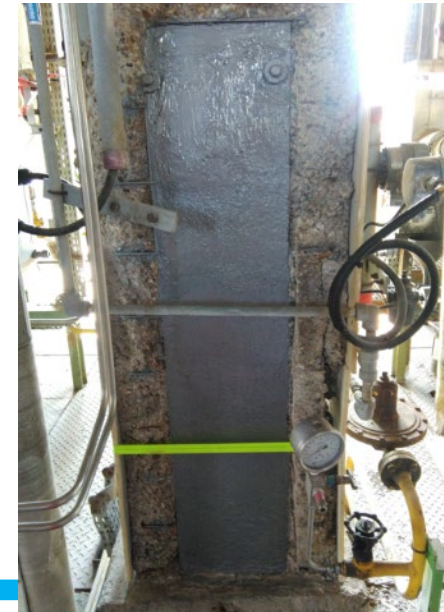
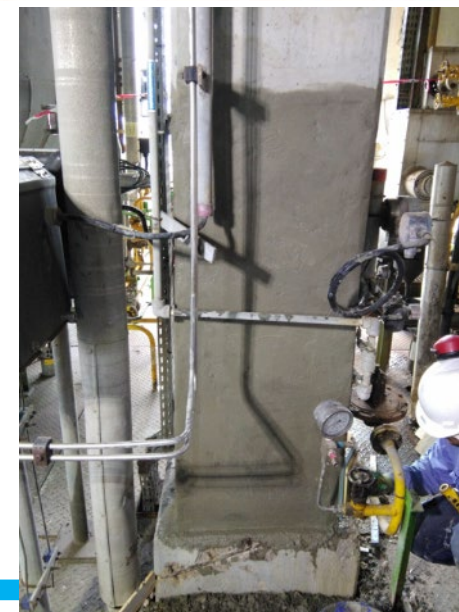
FR Repair Mortars and Putties

For Jet and Pool Fire Repairs

Tested
Time limited
Size limited

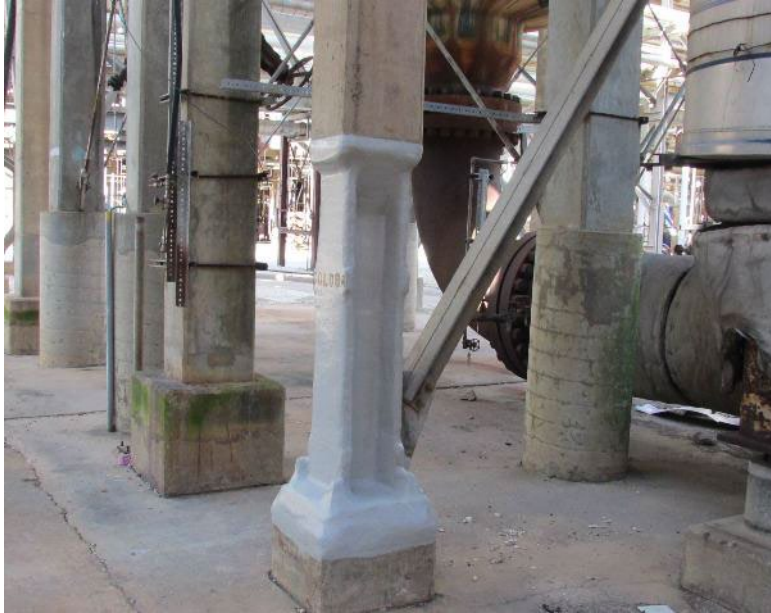
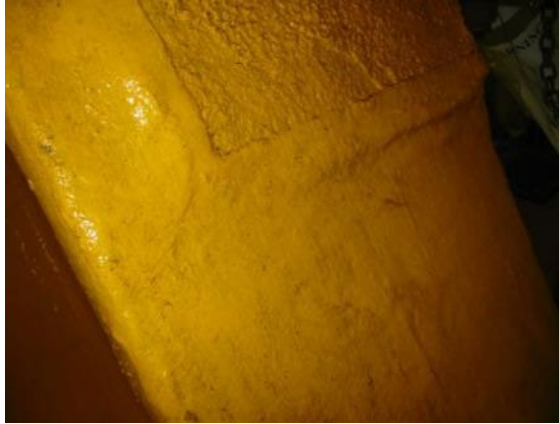
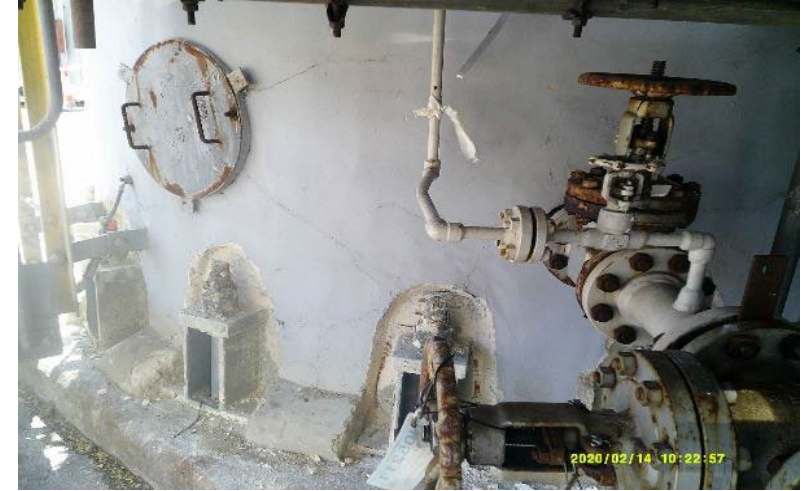
Long Term Repairs

Tested
Not Certified
Manufacturer recommended

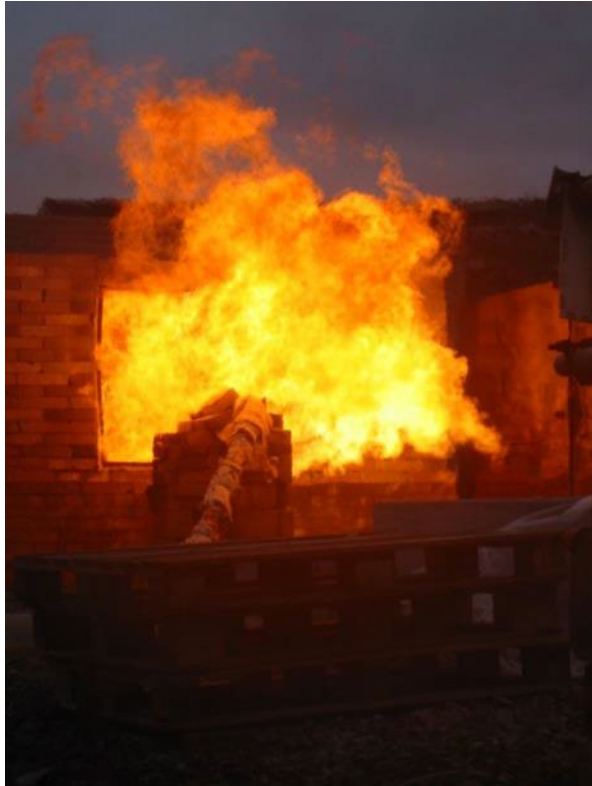
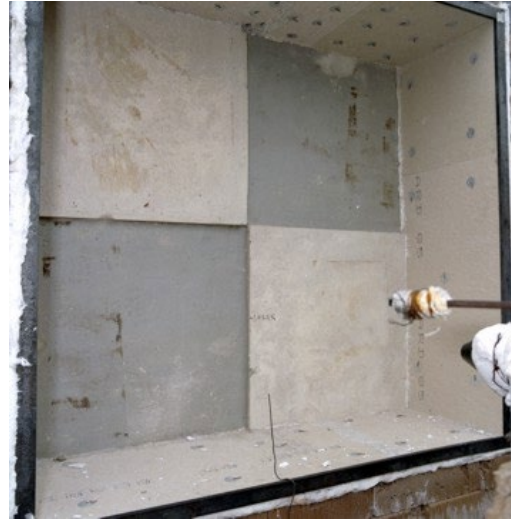
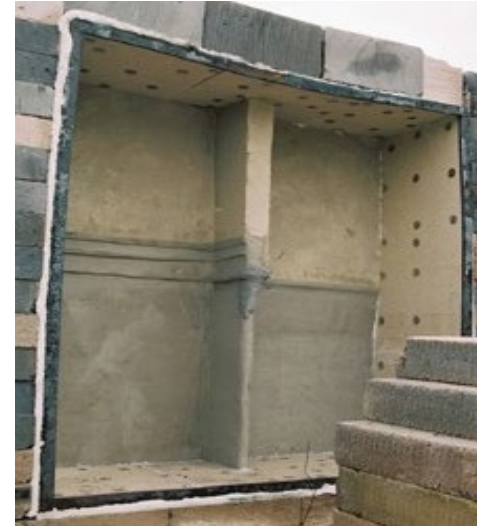
Dissimilar Material Repairs

Simple butt joint

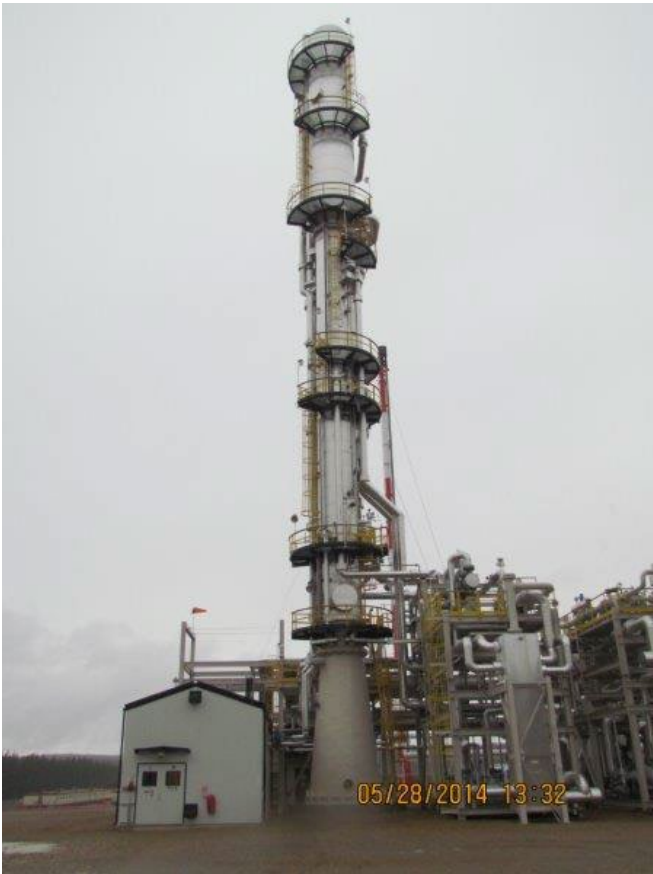
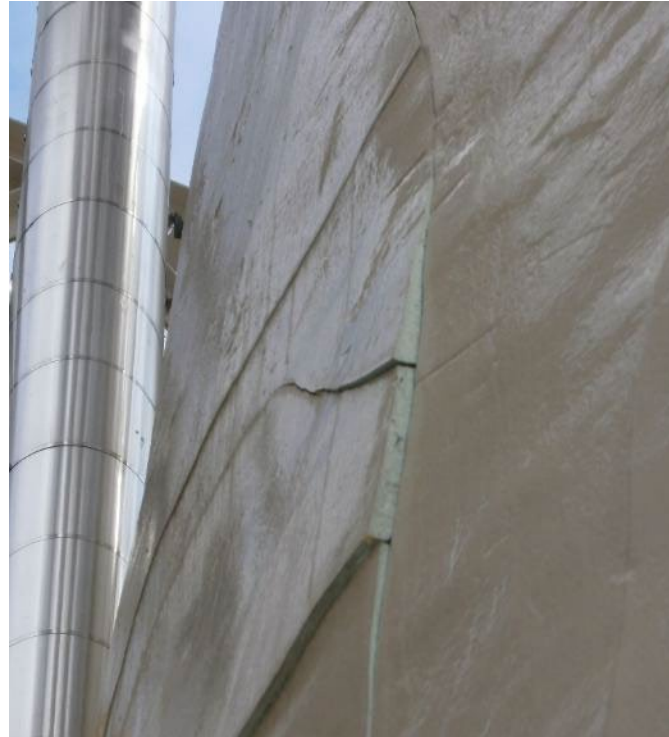
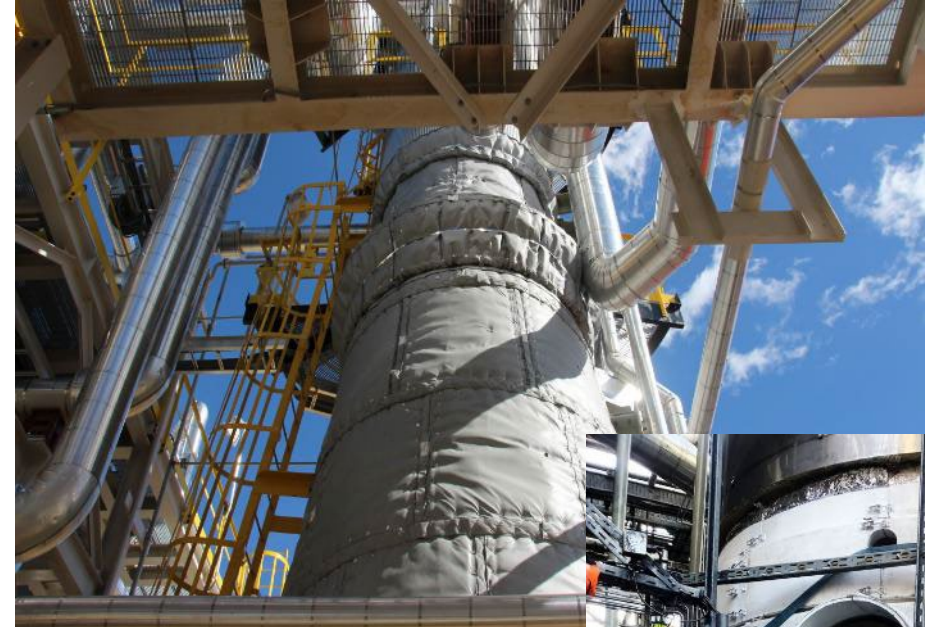
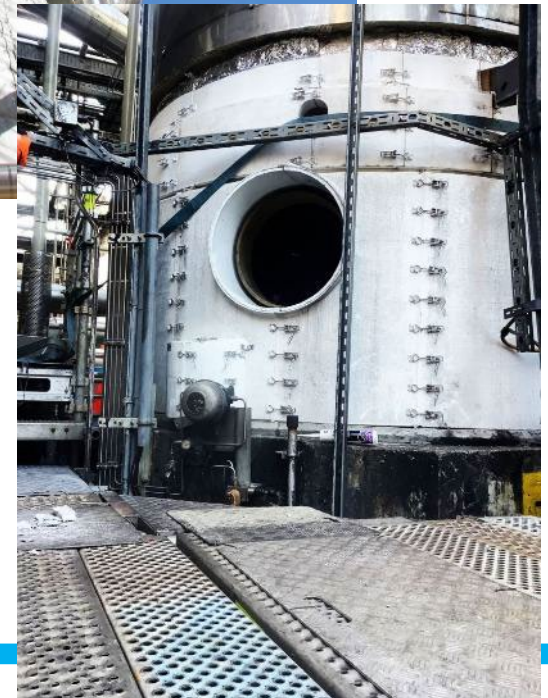
Long Term – Overclad Repairs

Adaptations from other certifications (eg vessels)
Require “confidence” in what is happening beneath

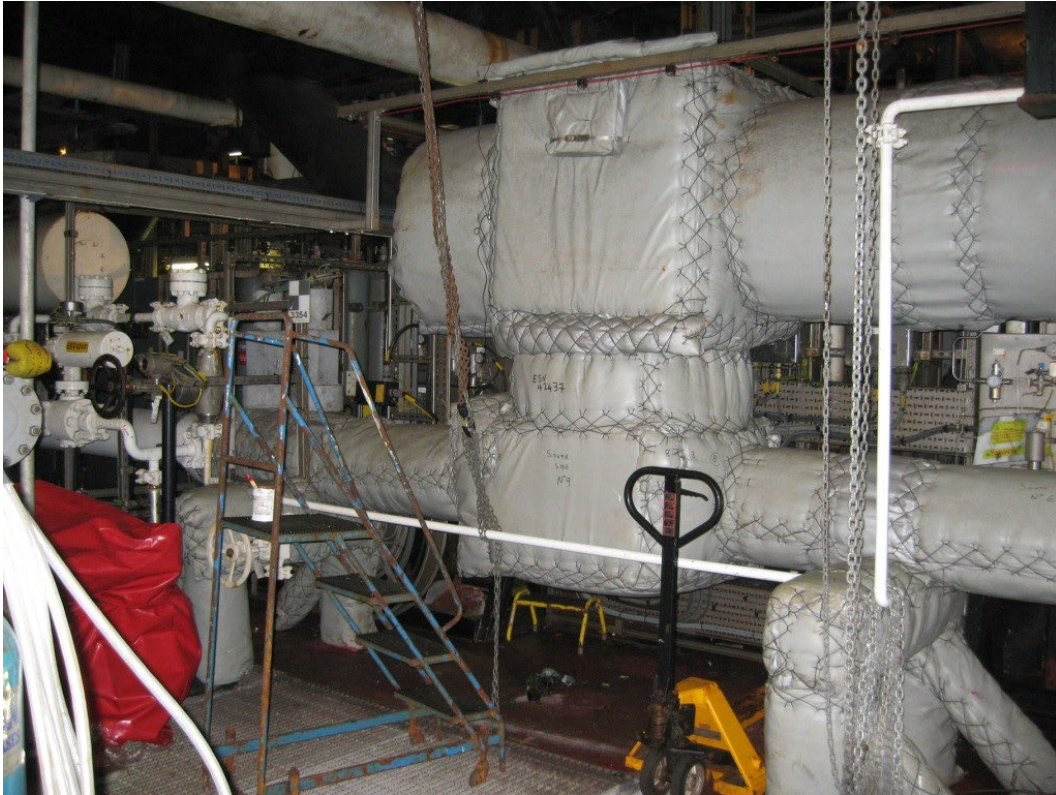
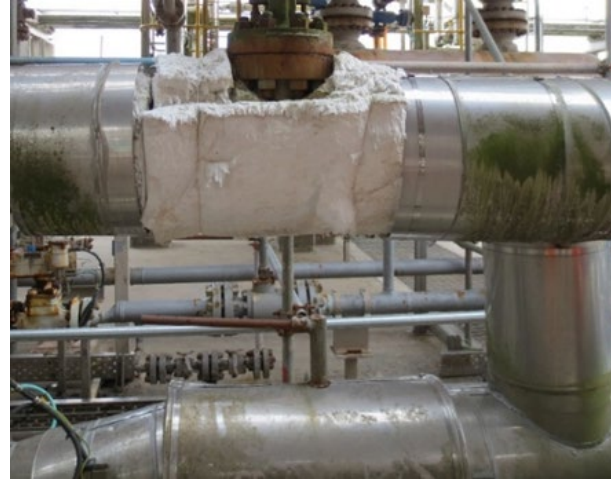
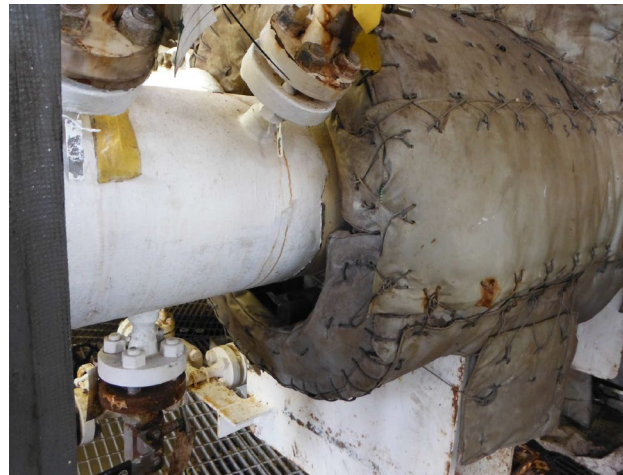
Component-Based System Repairs

If a component or fixing is missing – replace it

Panels and
components are
easily replaced
